EFFECTS OF REPEAT HIGH-SEVERITY FIRE ON
HEADWATER STREAMS ALONG THE MOGOLLON RIM

A Thesis

Northern Arizona University

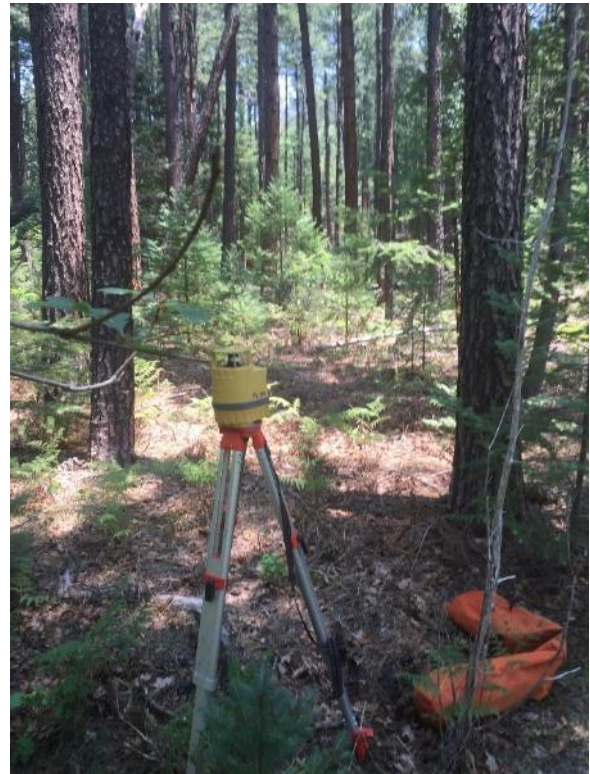
Figure 1.3: Photo of Topcon laser level

Geomorphology surveys were conducted using an RL-HA Topcon rotary laser level (Topcon Corp., Tokyo, Japan) with an accuracy of ± 25 cm at 50 m (Figure 1.3). A cross-sectional profile of the channel was created using measurements of vertical displacement along a horizontal line.

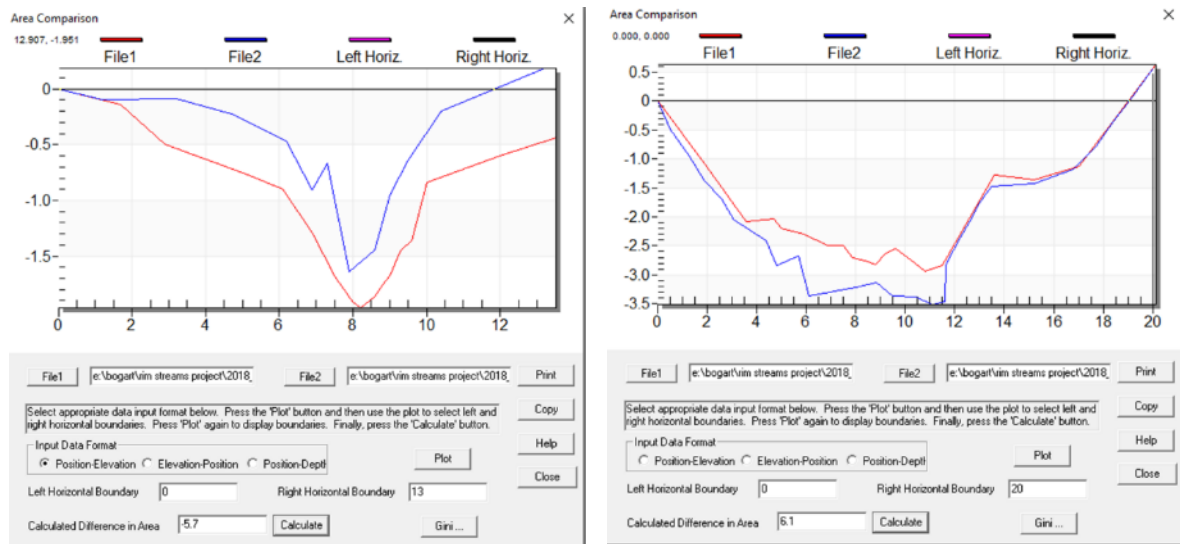
Figure 1.4: Example of WinEXSPRO outputs. The image on left is an example of a transect that was disregarded due to the difference on the right edge of the chart. Start points and end points should be in the same place as seen in the image on the right.

Cross sectional survey data was analyzed using WinXSPRO software (Hardy et al. 2005). Estimated change in area was recorded for each transect comparing one year to another. Some of the transects were not useable due to errors noticed when

inputted into the WinXSPRO program. The start points and end points should be static since they were denoted with rebar on the banks above the floodplain. Errors were likely due to the comparison of historic transects that had extra transects or rebar (Figure 1.4). Transects with errors were not used in the comparison.

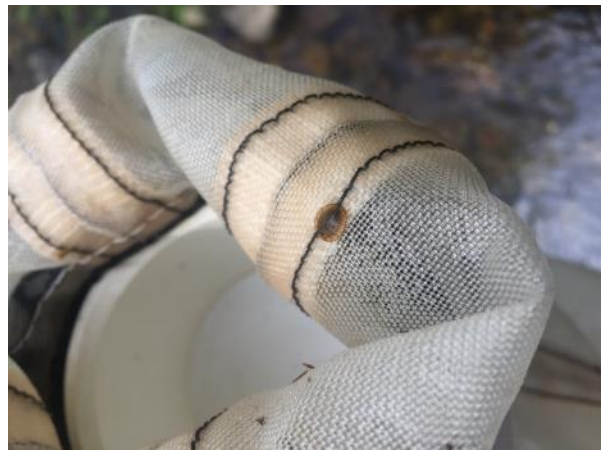
Figure 1.5: Macroinvertebrate on the Surber sample net.

Macroinvertebrate samples were collected at each transect on all five streams in 2011, 2018, and 2019. Samples were also collected in 2017 on Ellison and Bonita Creek after the fire but before the flood (Figure S4.2). The sample procedure included using a using a hard-bristled brush to scrape channel substrate within a 0.09 m²

Surber sample frame. Samples were taken within the transect at similar riffle habitats and preserved in 90% ethanol diluted with stream water. Samples were preserved on ice for transportation from the study area to the lab. The sample methodology was equivalent to the process done in the

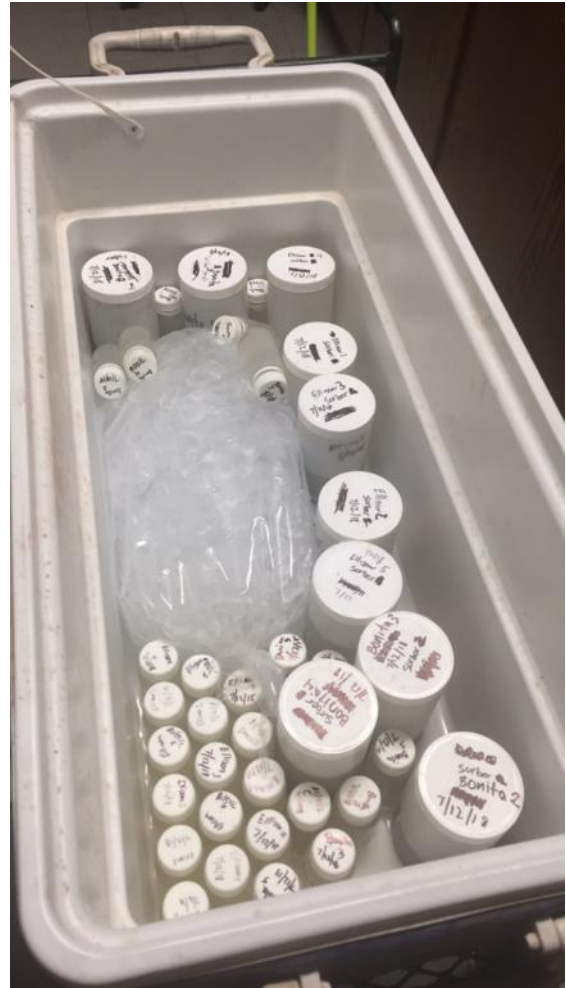
Figure 1.6: Macroinvertebrate and water quality samples stored on ice for transport.

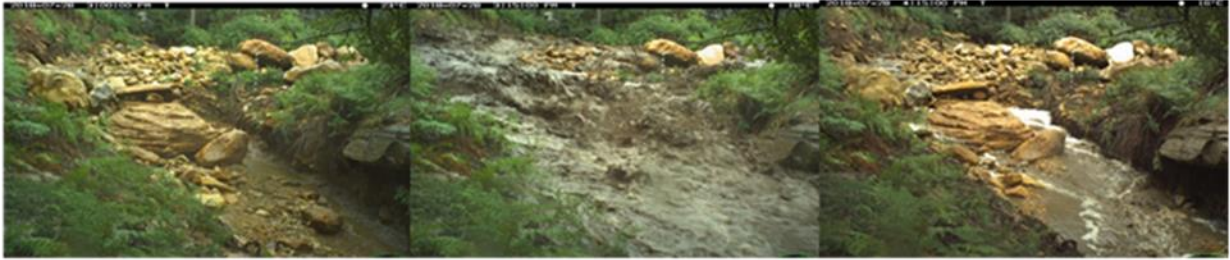
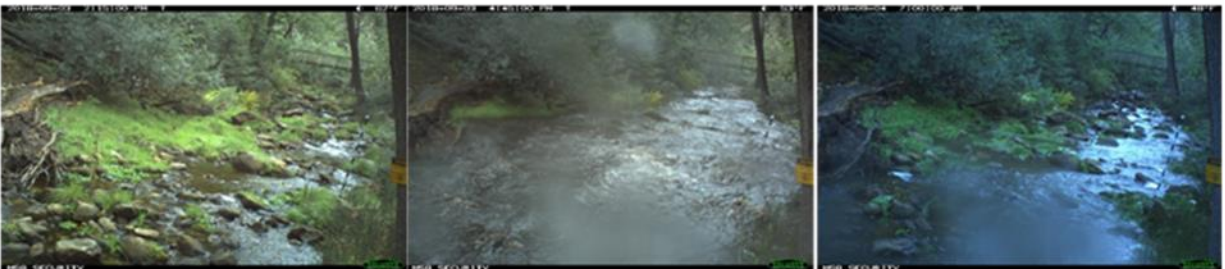
Sequence of flood photos at Ellison Creek above Transect 1. Photo on left taken July 28, 2018 at 3:00 PM. Middle photo taken on July 28, 2018 at 3:15 PM. Photo on right taken on July 28, 2018 at 4:15 PM

Sequence of flood photos at Ellison Creek above Transect 1. Photo on left taken Feb. 14, 2019 at 5:45 PM. Middle photo taken on Feb. 15, 2019 at 7:00 AM. Photo on right taken on Feb. 15, 2019 at 8:15 AM. See large boulder fall from right bank.

Sequence of flood photos at Pine Creek below Transect 2. Photo on left taken Sept. 3, 2018 at 2:15 PM. Middle photo taken on Sept. 3, 2018 at 4:45 PM. Photo on right taken on Sept. 4, 2018 at 7:00 AM

Figure 2.3. Stream photography results from Ellison Creek (top two sequences) and Pine Creek (bottom).

al. 2008), it is likely still in flux, and particle size may continue to change with the aggressive seasonal floods observed on Ellison Creek (Figure 2.3). Repeat photography on Ellison shows that much of its riparian vegetation, including small trees and sedges, was removed from 2017 to 2019 (Figure 2.4). The loss of this bank stabilizing vegetation exacerbates continued instability of the stream channel.

stable stream conditions in the study area. Photos captured on Pine Creek show that in cases of high flows, water levels slowly increase, but when returned to low flow the riparian vegetation and channel substrate remained undisturbed (Figure 2.3). Pine Creek only lowered one size class to medium cobble and Horton's 2019 collection resulted in large cobble as the dominant class, although there was no previous pebble count data to compare on Horton. The minimal change on Pine Creek and identification that Horton Creek's channel substrate is cobble, suggest overall stability of stream health on the reference streams (Duan et al. 2008).

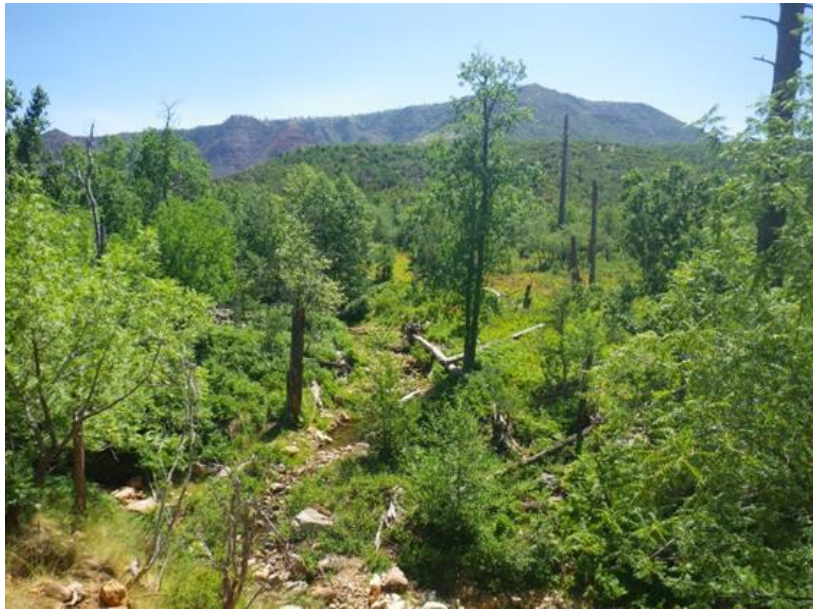
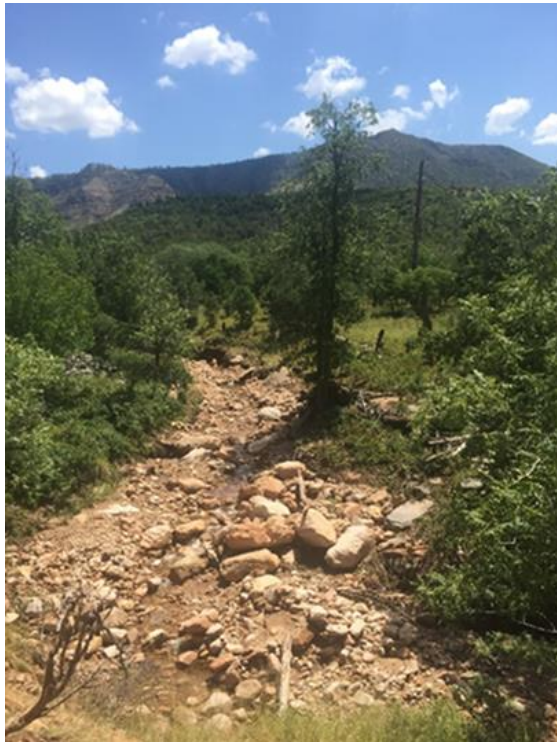
Ellison Transect 2 July, 2017

Ellison Transect 2 July, 2019

Figure 2.4. Repeat photography of Ellison Creek's transect 2. Top photo displays the stream post-fire, pre-flood. The bottom photo displays loss in riparian vegetation and channel movement.

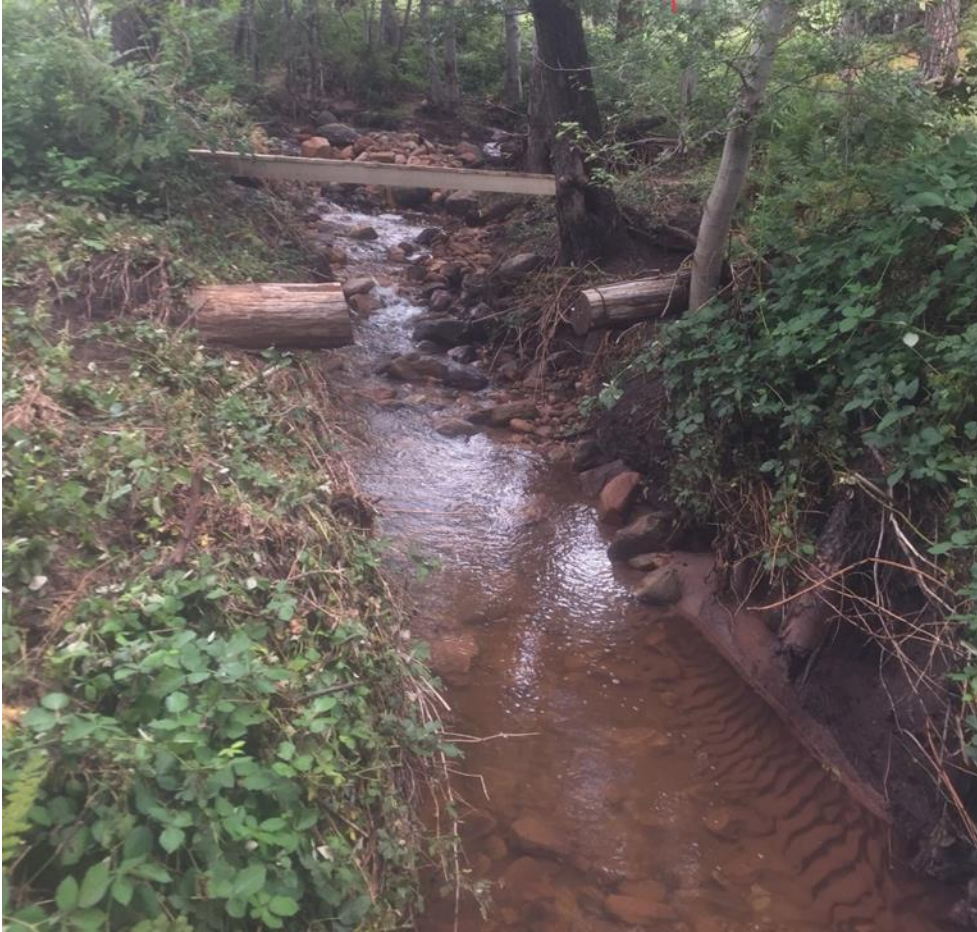
Figure 2.5. Signs of recent high flows on Bonita Creek. Riparian vegetation disturbed on banks.

Bonita, the other creek that had its watershed burned to a similar extent and severity in the Highline Fire (Table 2.1), did not respond with similar amounts of channel change as observed for Ellison. Bonita Creek's transect survey found an average loss of 0.6 square meters from 2011 to 2018, which was less change in area than Dude Creek and the unburned reference streams. It also had no change in the streambed dominant particle size. Field observations indicated that bankfull floods had occurred (Figure 2.5) but results from the geomorphology data collection suggest that sediment transport was minimal, and the stream remained physically stable due to the intact riparian woody vegetation that survived the both fires.

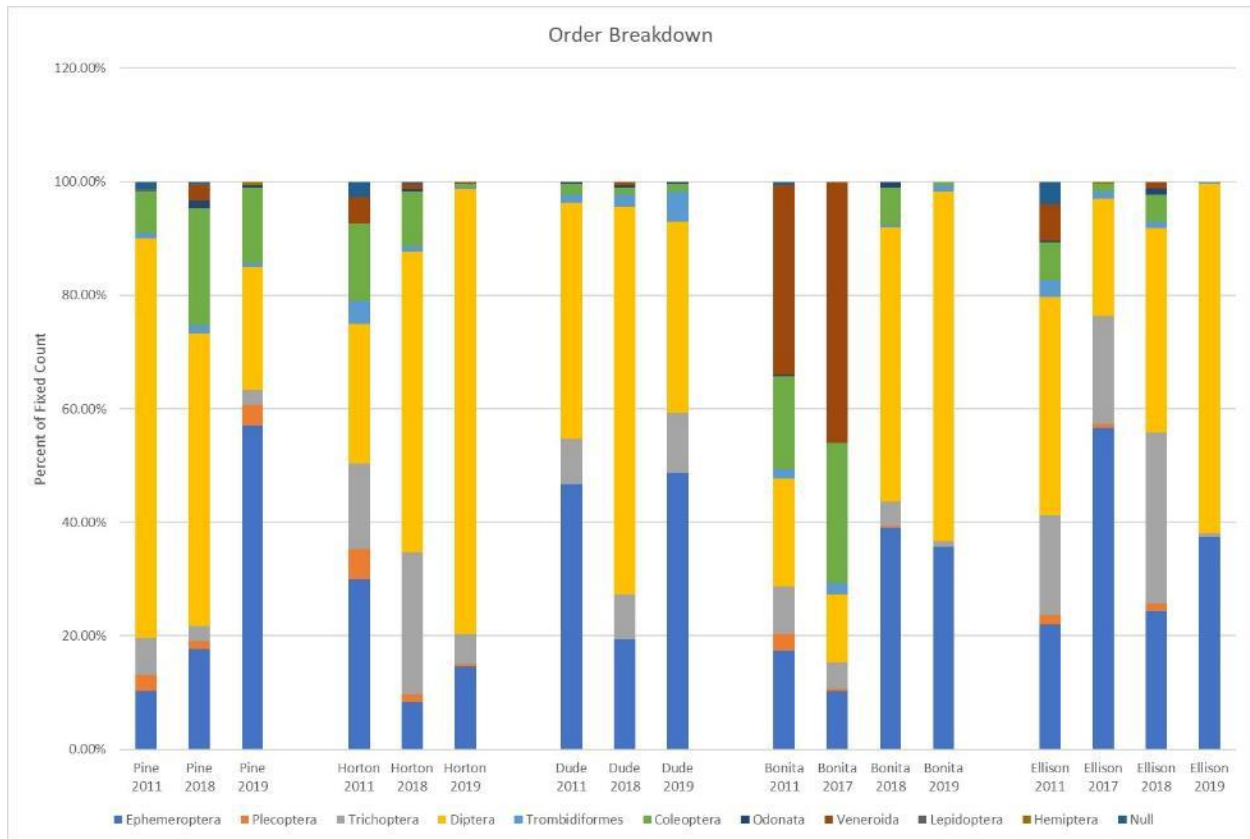
Figure S4.2. Order breakdown for all streams including grab samples from 2017.
