**Analysis of Current and Historical Surface Flows and Hydrologic Response to
Restoration Treatments in the Upper Lake Mary Watershed, Arizona**

Professional Paper
Submitted in Partial Fulfillment of the
Requirements for the Degree of
Master of Forestry

Northern Arizona University

August 2007

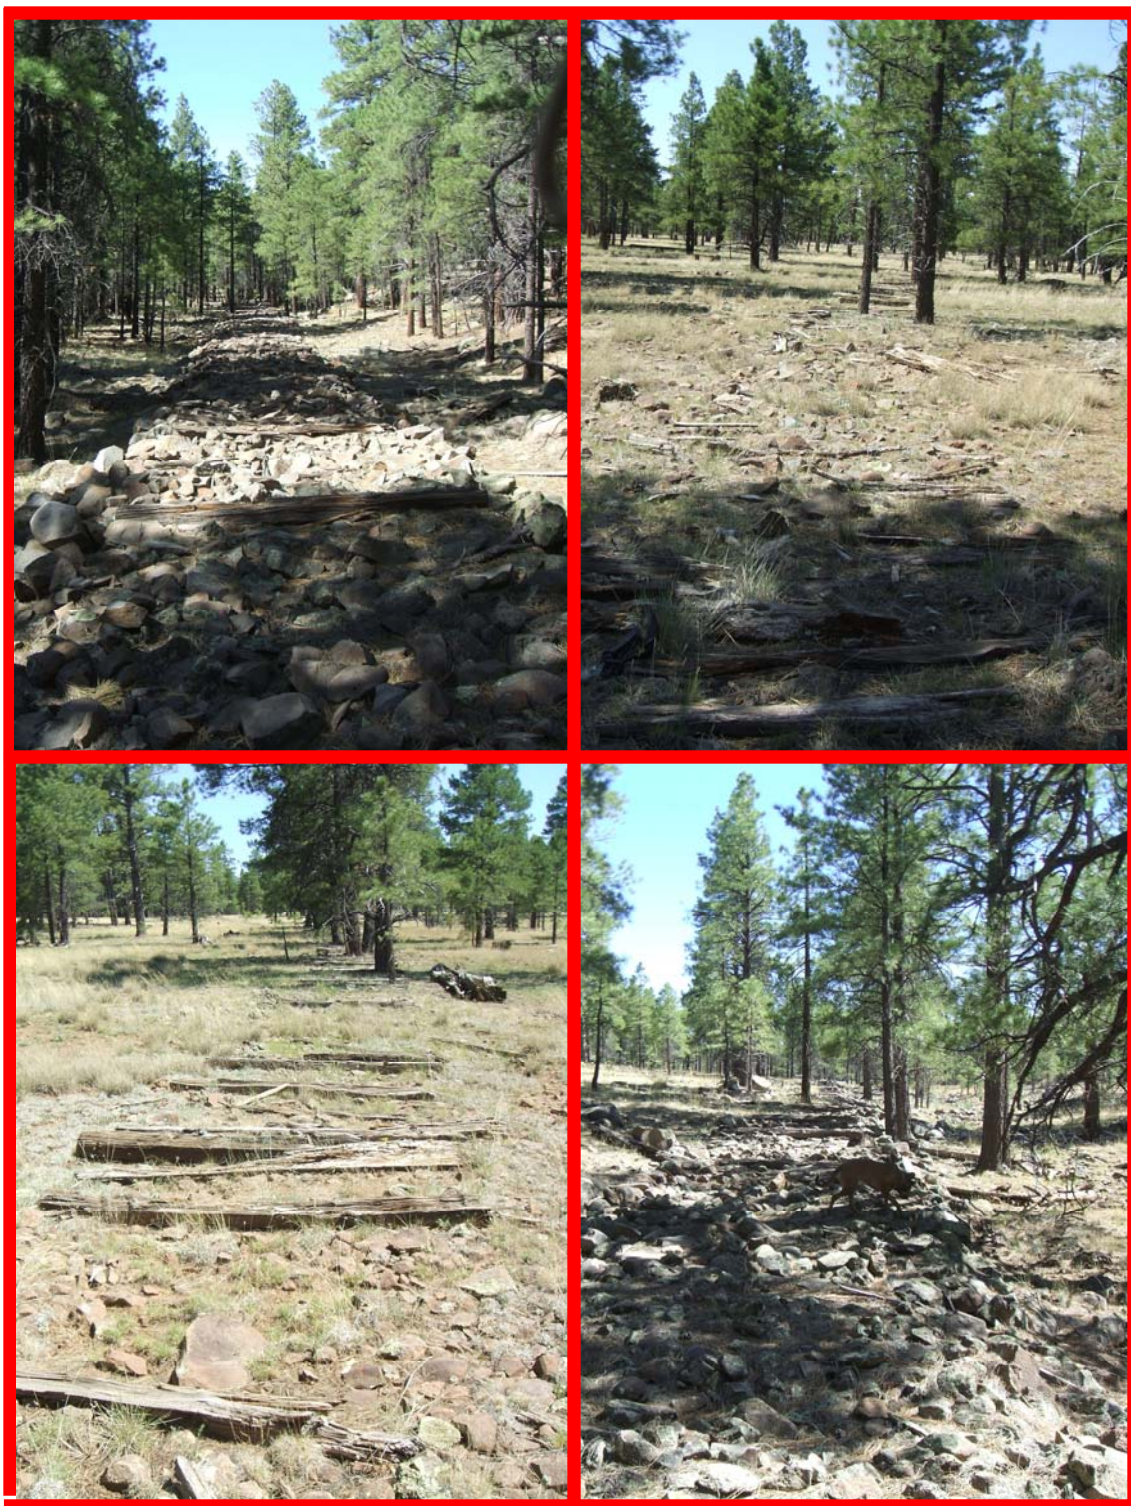
Figure 5. Remnants of early 1900's era railroad spurs used to harvest timber in the Upper Lake Mary watershed.

constructed into the watershed, which facilitated widespread logging activity (Figure 4). Remnants of these spurs are still present in many areas (Figure 5). Intense logging operations occurred between 1900 and 1924, with limited timber sales continuing through the early 1940's. There have been no timber sales in the watershed since then, and few large-scale management activities, inventories, or silvicultural or other data collected and / or archived. Planimetric analysis of the timber atlas maps reveals that 77.7%, or 26,435.4 acres (10,698 ha), of the Upper Lake Mary watershed was harvested between 1900 and 1924. 3,152 acres, or 9.3% of the watershed area, were cut prior to the establishment of the U.S. Forest Service, and were clearcut of all mature timber with no seed trees left. The remaining areas were high-graded, meaning that nearly all merchantable timber was removed without regard for regeneration or how harvesting scheme might weaken the local gene pool by removing the healthiest, most vigorous trees (Mike Manthei, Timber Staff, Coconino National Forest, personal communication, 2007). These harvesting activities, combined with suppression of natural wildfires, have resulted in conditions that are similar to conditions in numerous other stands of ponderosa pine on northern Arizona. Overstory density has increased dramatically, shifting from old and large trees to numerous younger, smaller, suppressed trees. However, the Upper Lake Mary watershed still contains many openings, parks, and meadows, and the doghair thickets and degree of canopy closure do not appear quite as extensive as in some other areas of the Coconino National Forest. In addition, the watershed contains many young Gambel oak clumps, with up to 30% of the canopy cover by oak in some areas. Timber harvests of the type that occurred in the Upper Lake Mary watershed impact forest regeneration and successional trajectories following disturbances. Fulé et al. (1997) described conditions similar to those found currently in the watershed, and hypothesized that heavy logging eliminated seed sources and prevented the establishment of

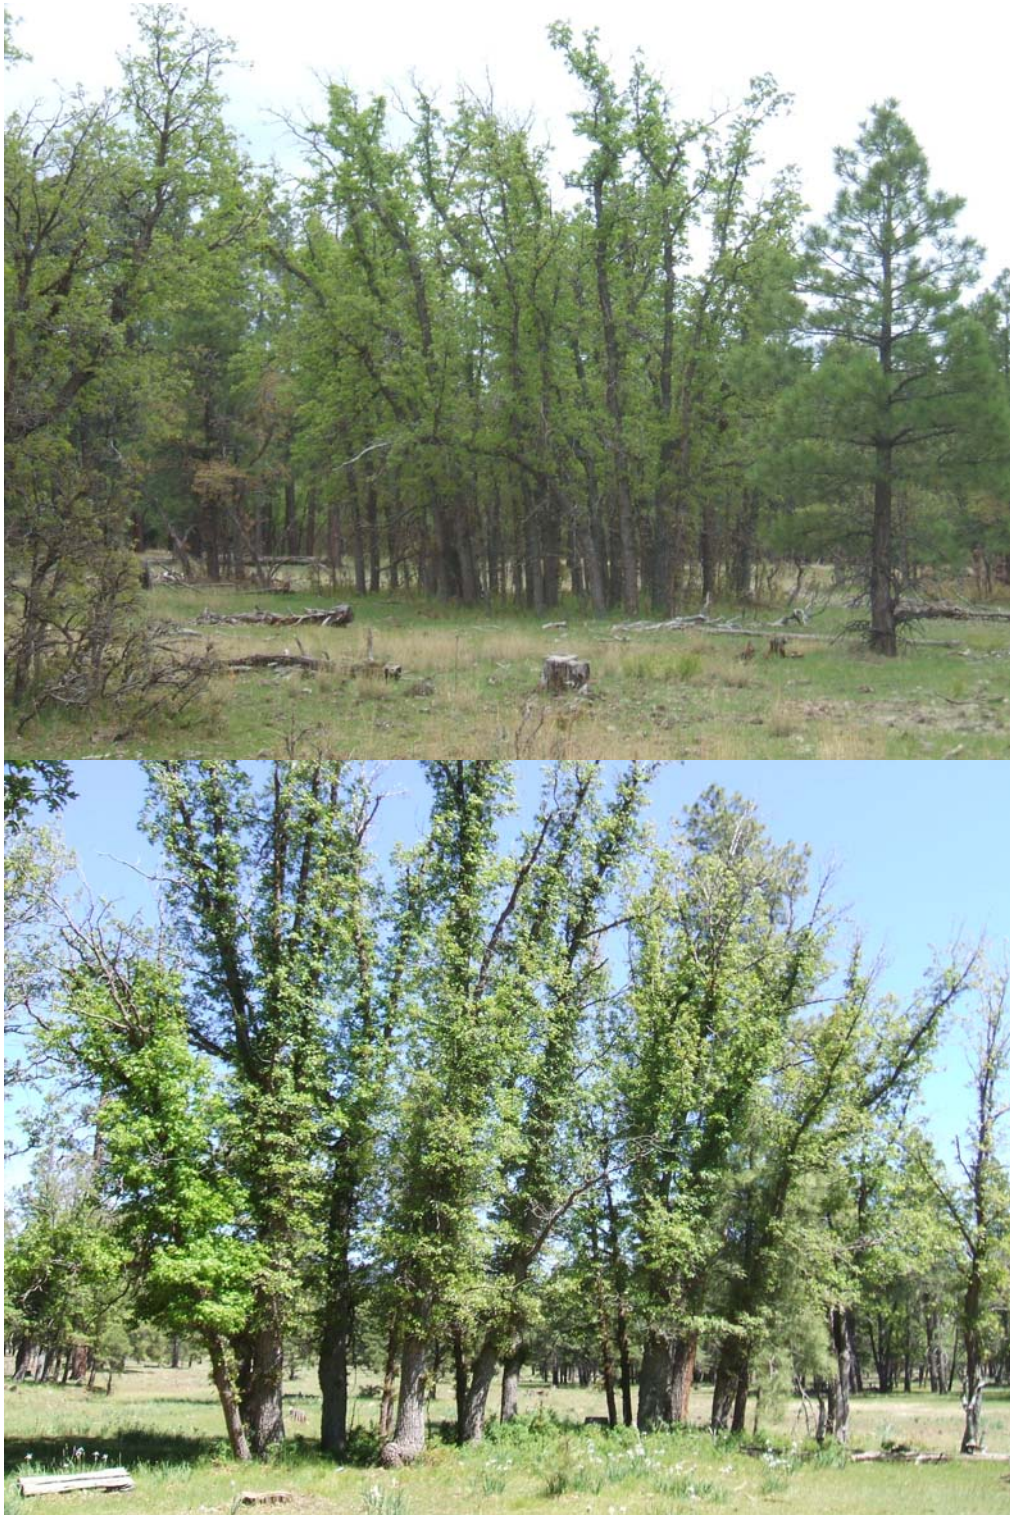
Figure 6. Clumps of Gambel oak (*Quercus gambelii*) are abundant in the Upper Lake Mary watershed.

seedlings even during good seed years. This could be one reason why there are so many oak stems in the Lake Mary area (Fulé et al. 1997, Figure 6).

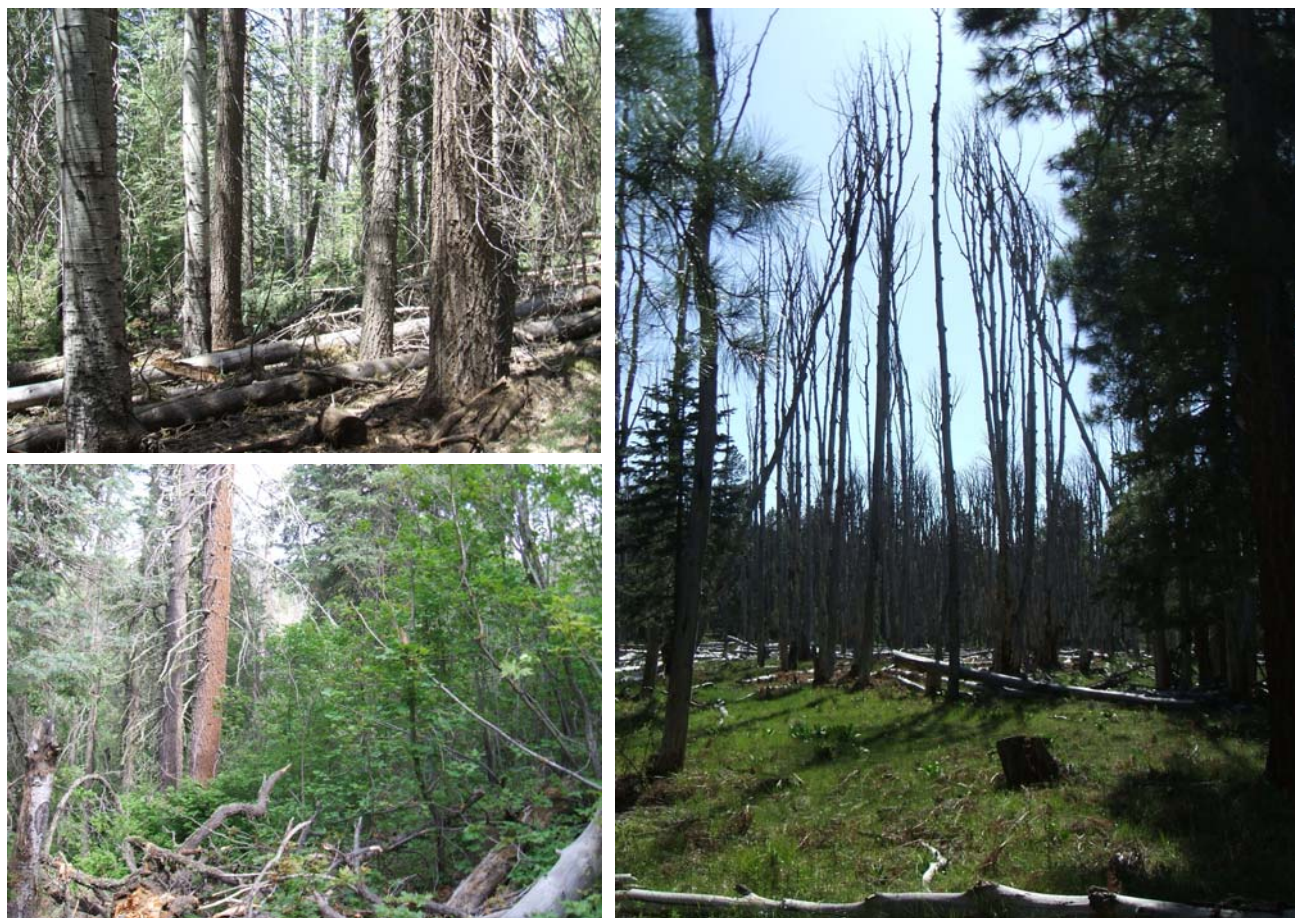
Figure 9. Dead standing trees, dense forest overstory conditions, high levels of coarse woody debris, and the presence of ladder fuels characterize much of the mixed conifer strata in the Upper Lake Mary watershed.

pushed or pulled from the ground with bulldozers, pairs of which often ran parallel with a heavy chain between. The purpose was to create livestock forage, although it was of limited benefit in this regard. The mixed conifer strata (6 and 8) show marked differences between current and presettlement basal areas (Table 5). In addition, they were the only strata to have greater than one snag (dead standing tree) per plot (Table 7). Although dead standing trees were not located in every plot in these strata, certain areas within these strata are at high risk for catastrophic wildfire. These areas have extremely high densities of both live and dead standing trees, and most of the strata area shows relatively high levels of coarse woody debris (Figure 9).

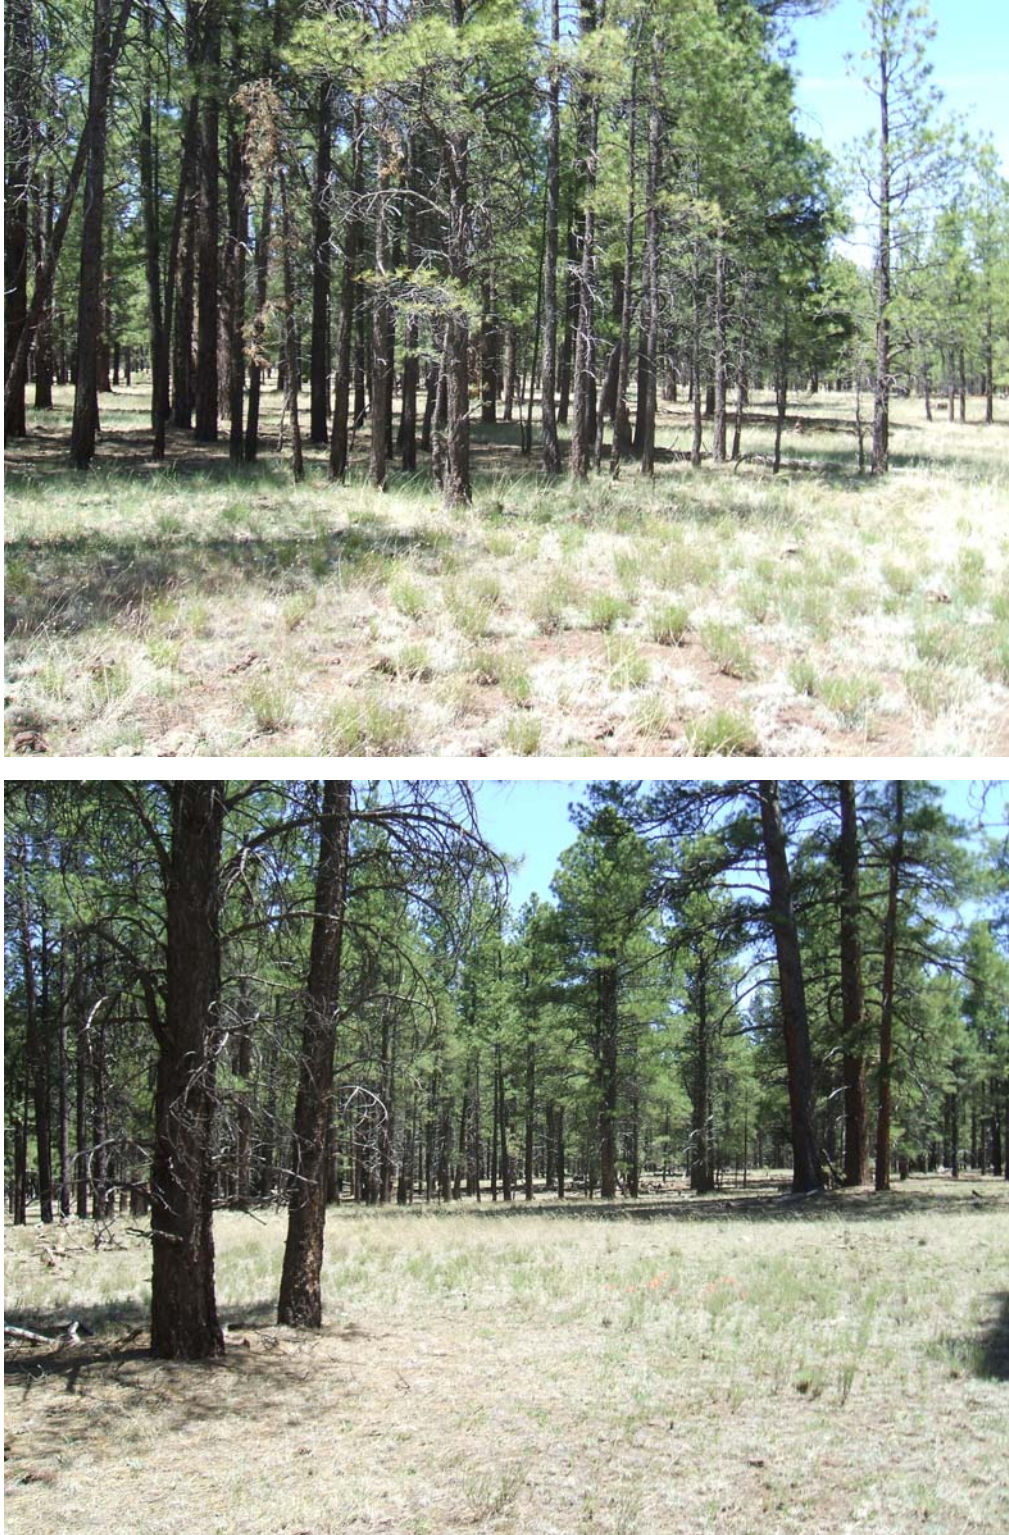
Figure 11. Overstory structure in the Upper Lake Mary watershed is highly variable. Despite the presence of doghair thickets and dense pole stands that have formed since European settlement, numerous openings still exist.

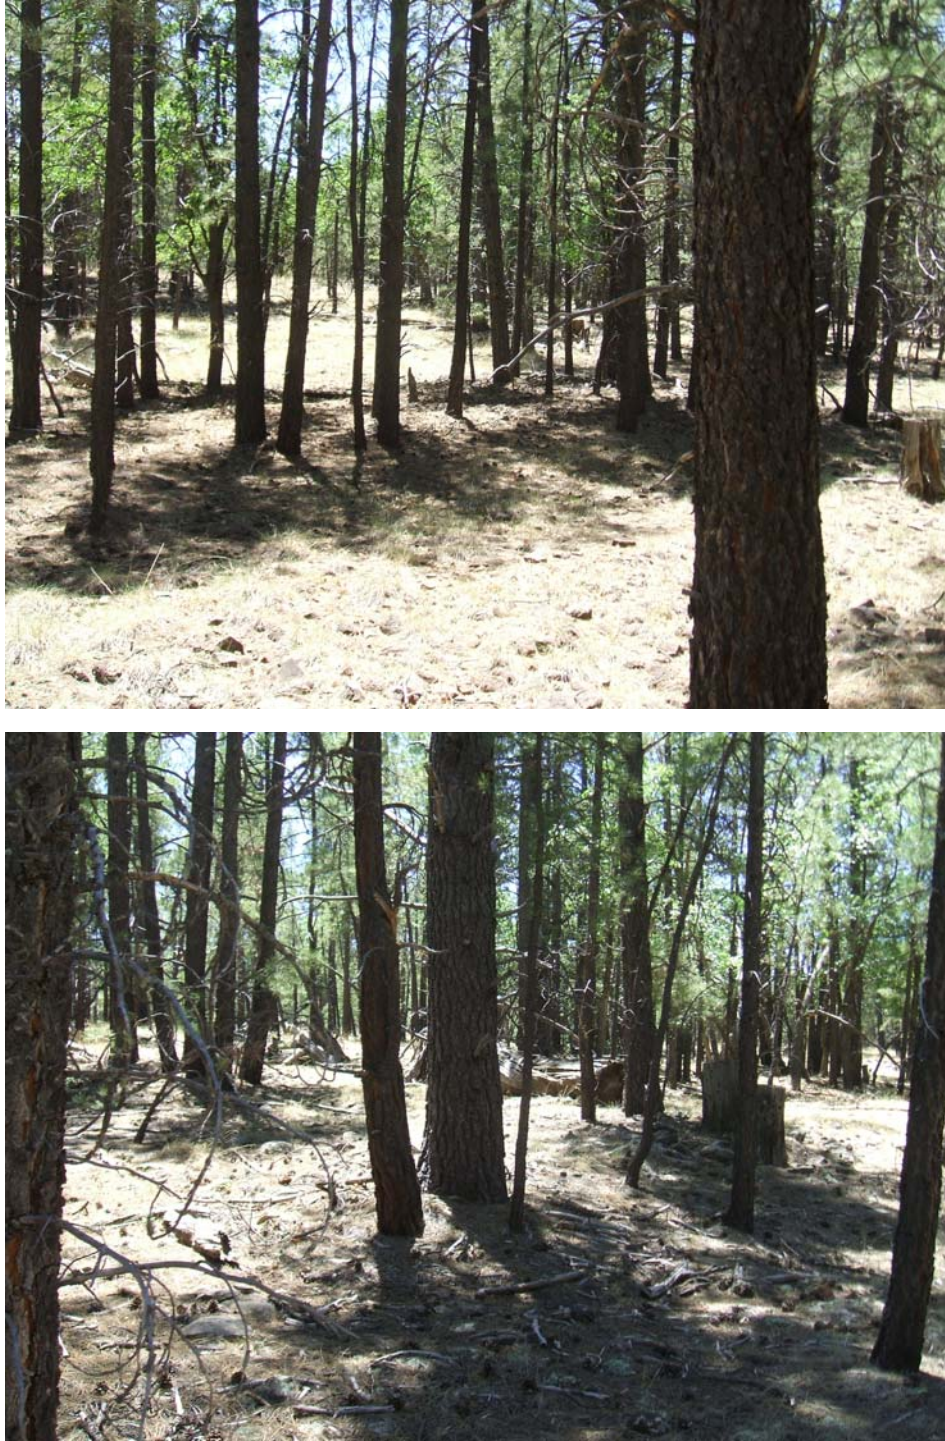
Figure 12. Doghair thickets and dense pole stands in the Upper Lake Mary watershed contain suppressed trees and have high degrees of canopy closure. Herbage production in these stands is very low.

Because of high variability in forest structure within relatively small areas, some of the ecological effects of doghair thickets and dense pole stands could be easily observed (Figure 12). When compared with adjacent openings, stands of doghair thickets had much deeper litter and
